# PACSystems™ RX3i

## IC695CPU310-ER

### Central Processing Unit

GFK-2329T  
December 18, 2007

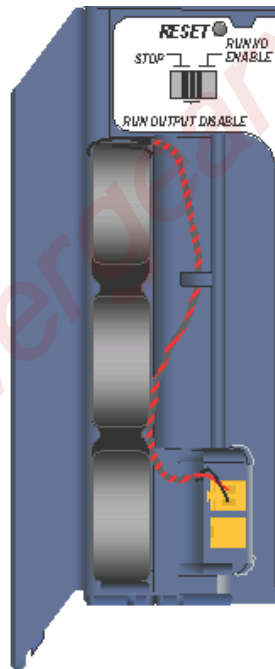
Mode Switch and Battery Compartment

To avoid loss of RAM memory contents, routine maintenance procedures should include scheduled replacement of the CPU's lithium battery pack. For information on estimating battery life, refer to the *PACSystems CPU Reference Manual, GFK-2222*.
